MARINE INVESTIGATION REPORT

M03N0050

FIRE ON VEHICLE DECK

JOSEPH AND CLARA SMALLWOOD

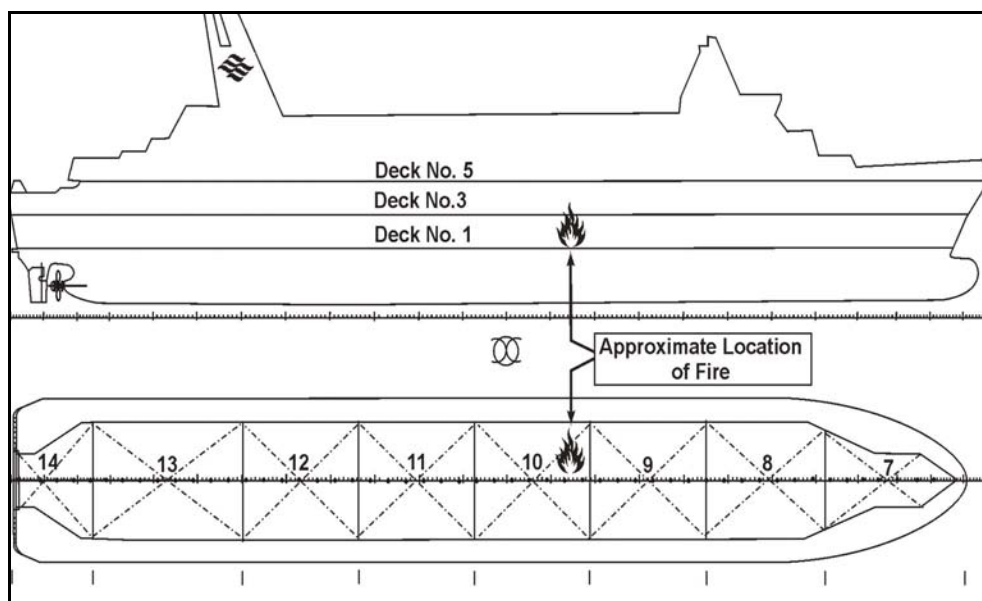
Figure 1. Deck 1 – Deluge zones and location of fire

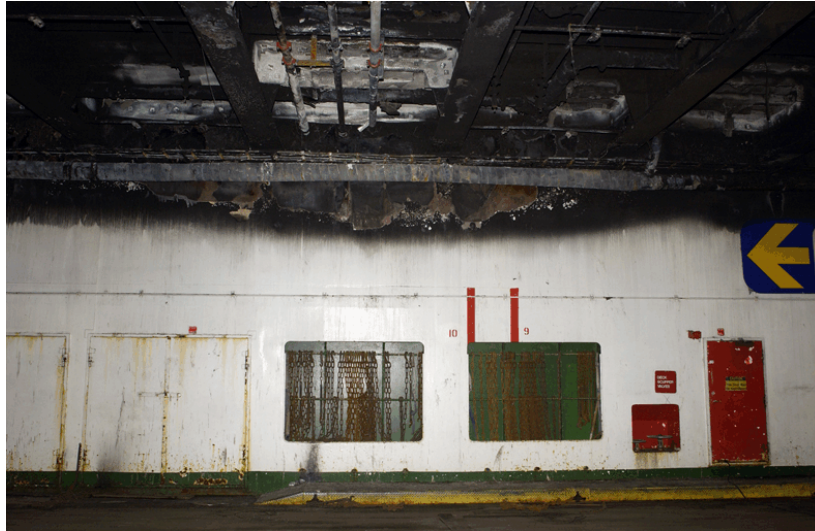
- Some 40 m² of deck plating above the origin of the fire was buckled.
- Some 40 m² of thermal insulation was damaged.
- Various electrical fixtures (for example, lighting fixtures, heat detectors, annunciators, associated wiring) were damaged.
- Various internal and external areas were smoke damaged.

Photo 2. Damage to deckhead

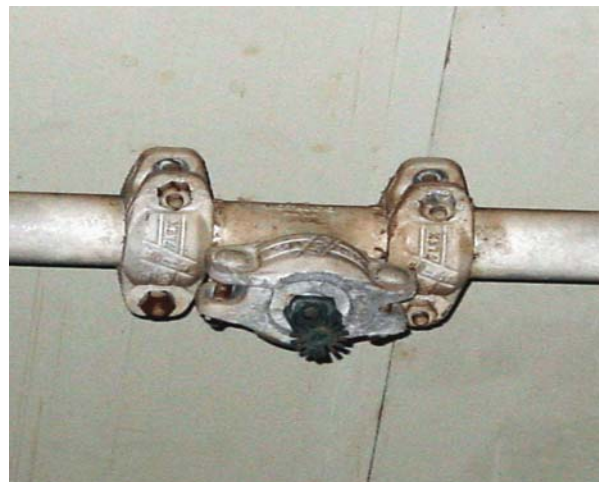
Photo 3. Deluge spray head

The primary function of the deluge system is to contain and control the fire and to provide cooling, thus allowing the crew an opportunity to better fight the fire. In this occurrence, the deluge system on board the *Joseph and Clara Smallwood* effectively limited the fire to the underside of the three burning vehicles.

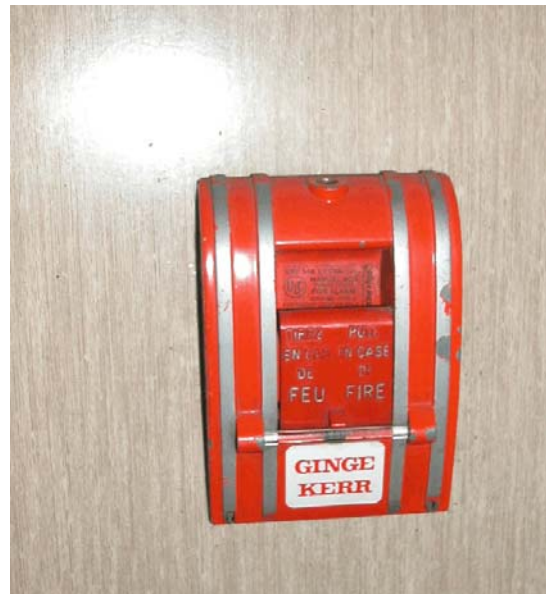
The manual pull stations on the *Joseph and Clara Smallwood* require the user to pull a lever down in order to send a pre-alarm signal to the bridge. No feedback is provided to the user about whether an alarm signal has been successfully transmitted until a bridge officer elects to sound the alarm, or the alarm is automatically activated after the preset time.

Crew members lacked understanding as to exactly what should occur when a manual pull station is activated. Some knew that the alarm would initially sound only on the bridge; some thought an audible

Photo 4. Typical manual pull station

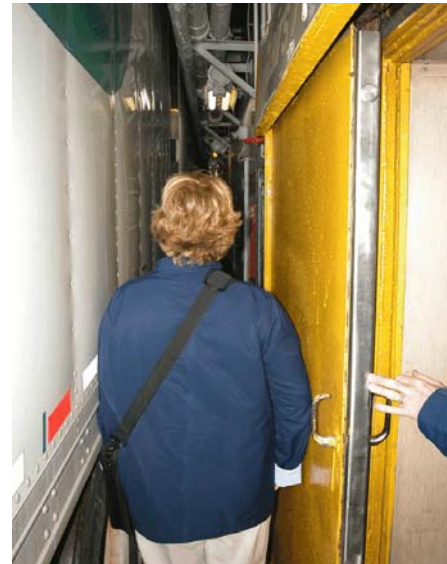
Photo 5. Typical spacing between vehicles and deck perimeter

During the occurrence, dense black smoke resulted in poor visibility, and the close spacing between the vehicles made it extremely difficult to access the fire. The fire team was also hampered by the physical limitations of a fully pressurized two-inch fire hose with which they were required to crawl around and under the trailers to gain access to the fire. These conditions increased both the amount of time required to access the fire and the physical effort expended by the firefighters. As a result, the ship's crew was unable to extinguish the fire, even though it had been effectively contained by the deluge system. Eventually, the stern door was opened and the deck was cleared of vehicles. This provided better access to the fire, which was then extinguished with the assistance of shore-based firefighters using their smaller (1 ½-inch-diameter) fire hoses.

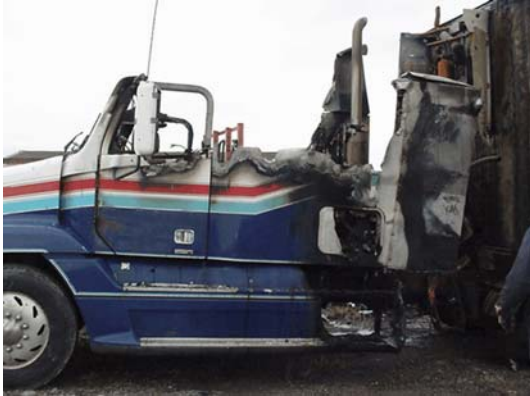
- One tractor truck was completely destroyed. Its attached trailer was heavily damaged and the cargo of orange juice destroyed.
- The contents of a moving and storage company trailer sustained heavy damage.
- A drop trailer with building supplies sustained heavy damage.
- Several other tractor-trailer rigs suffered varying degrees of smoke and water damage.
- A private motor vehicle sustained heat damage to the rear bumper, left tail-light and rear tires.

Tractor fire damage

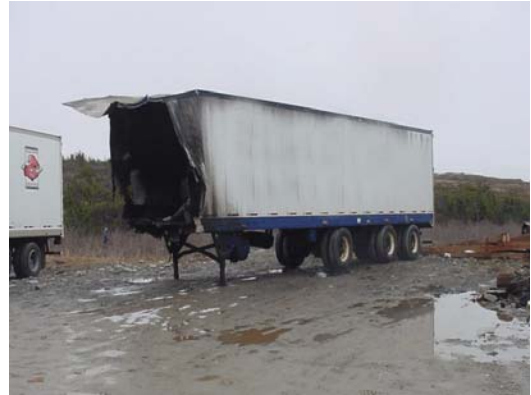
Trailer fire damage

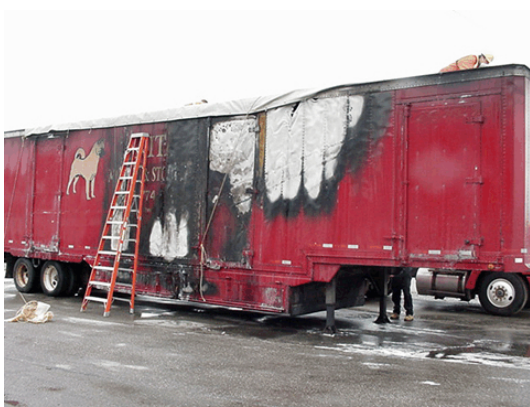
Moving and storage trailer fire damage

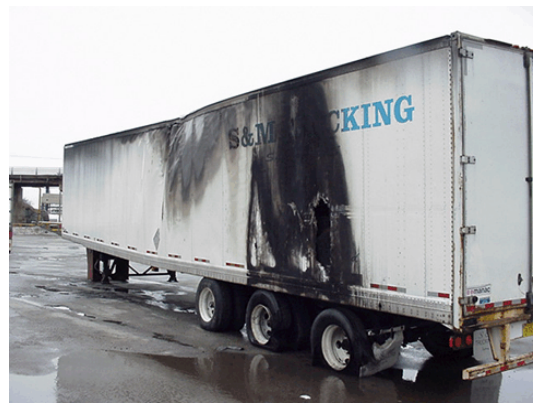
Drop trailer fire damage

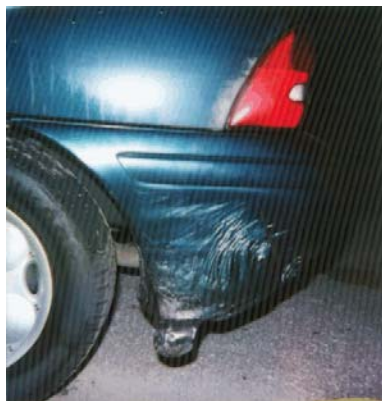
Private motor vehicle heat damage
